MAHAFFEY ASSOCIATES PTY LTD

Client: Brickworks
Job Number: 11464
Test Type: Determination of Impact Resistance of Panels
Test Method: Based on EOTA Technical report TR 001 Edition Feb. 2003
Product Name: Terraçade TN smooth
Product Size: Tiles 588 mm x 308.5 mm x 14 mm
Material: Fired Clay
Manufacture Date: Not Advised
Sampled by: Client
Sample Date: 7/12/2022
Received Date: 8/12/2022
Test Date: 8/12/2022

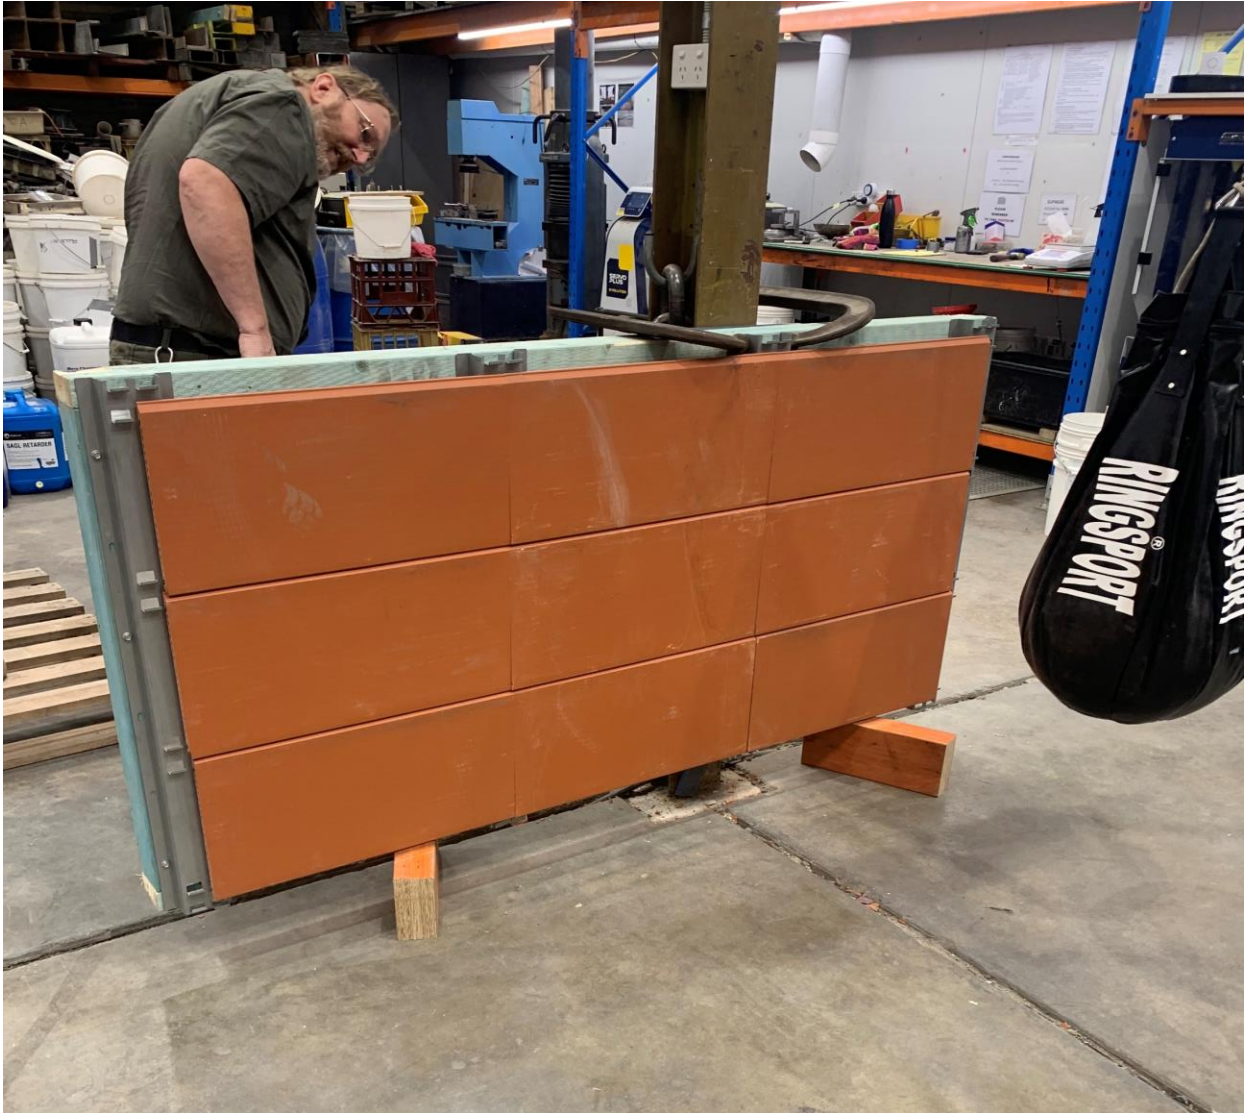
PHOTOGRAPH 1 - Soft Impact test setup

The Client supplied timber frames constructed from 90 mm x 45 mm MGP 10 onto which metal rails were screwed. The rails then supported the Terraçade tiles. The frames supported 3 Terraçade units high by 3 wide, and was therefore approximately 900 mm tall by 1800 mm wide.

The tests were conducted in the laboratory, using a steel column in the lab as the main support for the set up. The timber frame was clamped against the column with a 25 x 50 mm tube acting to space the frame away from the column. The test set-up can be seen in Photograph 1. The leather impact bag had a diameter of 450 mm. The bag was filled with sand that complies with the criteria of CEN Standard Sand as in EN 196-1, to obtain the desired total mass of 50 kg.

The impact bag was hung so as to cause the bag to impact the specimen at the mid-height of the test panel.

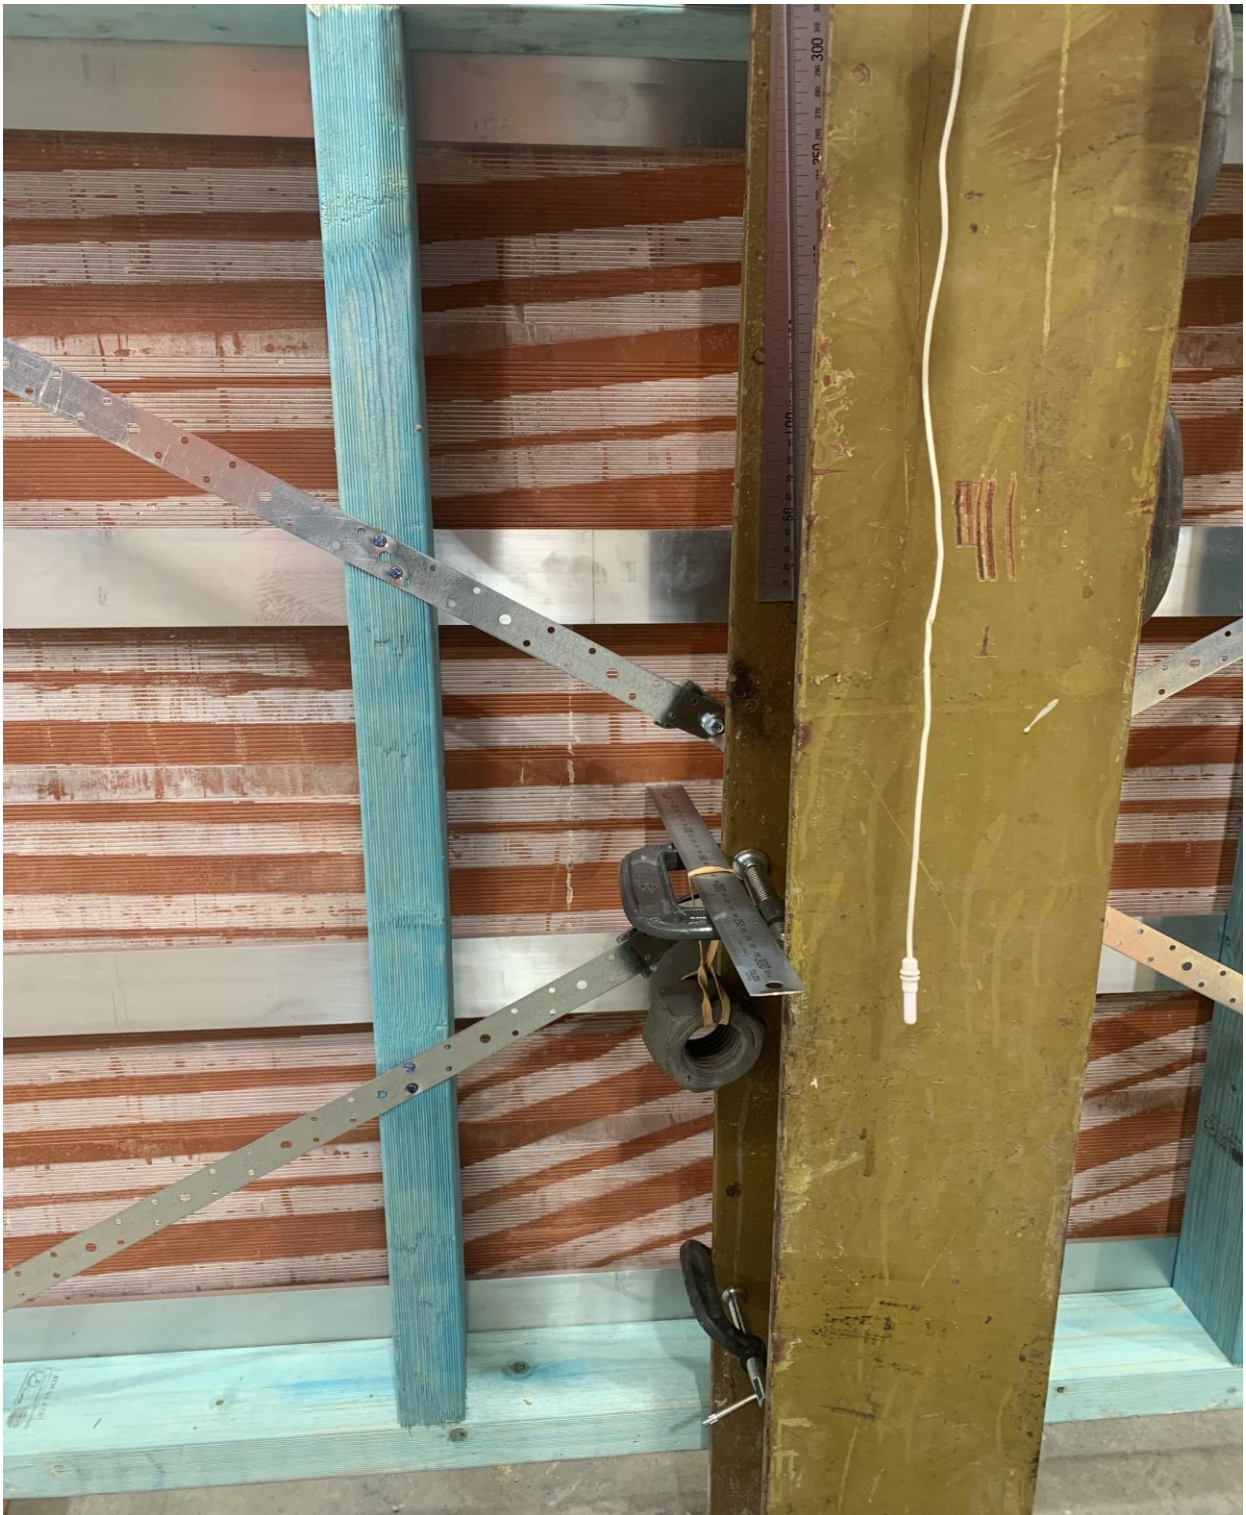
PHOTOGRAPH 2 - Soft Body Impact Test - Deflection Measurement - Note the steel rule

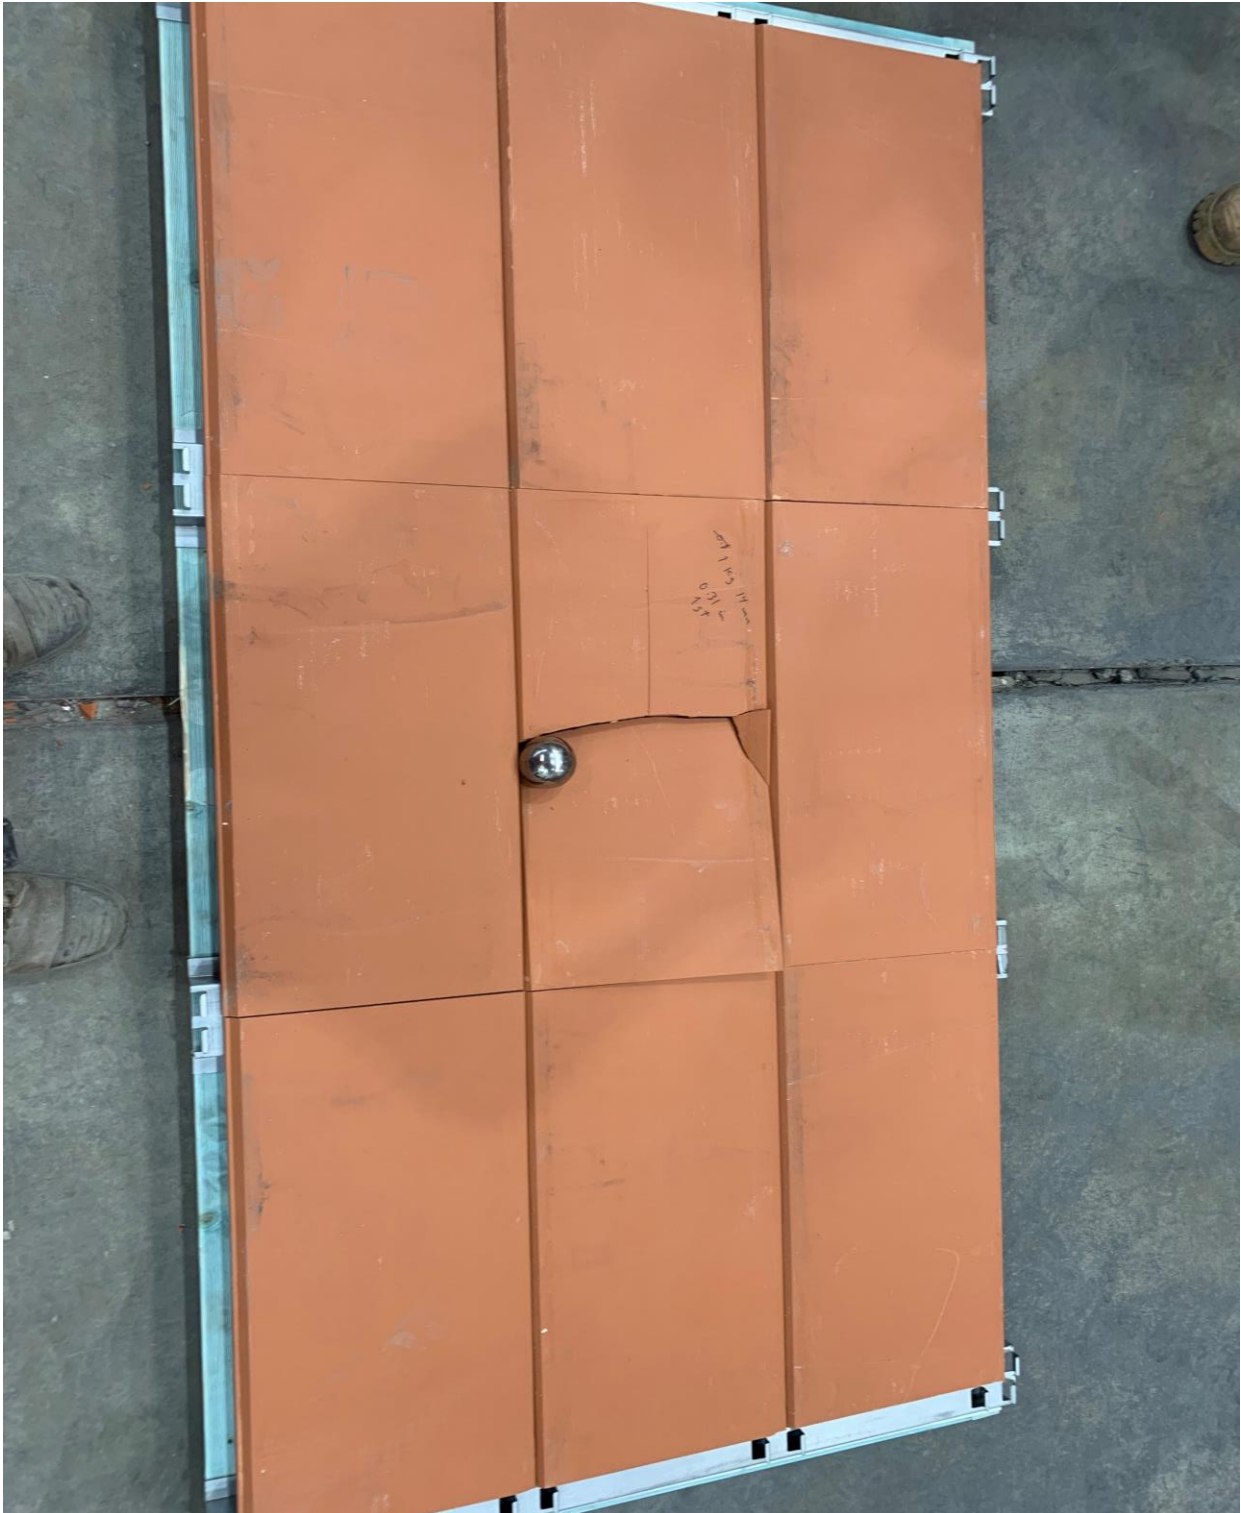
PHOTOGRAPH 3 - Hard Body Impact Test - Typical Panel after test

Two steel ball bearings of 0.5 & 1 kg mass respectively were used to simulate the hard body, each ball was dropped from different heights individually on the panel that to create the required impact energy on the panel. Damages were noted in the results below.
